# Inspection Report

**Property Address:**  
1234 Candy Lane  
Make Believe Land CA 111111

10/3/2020

**Harper Homes: Home Inspection Services**

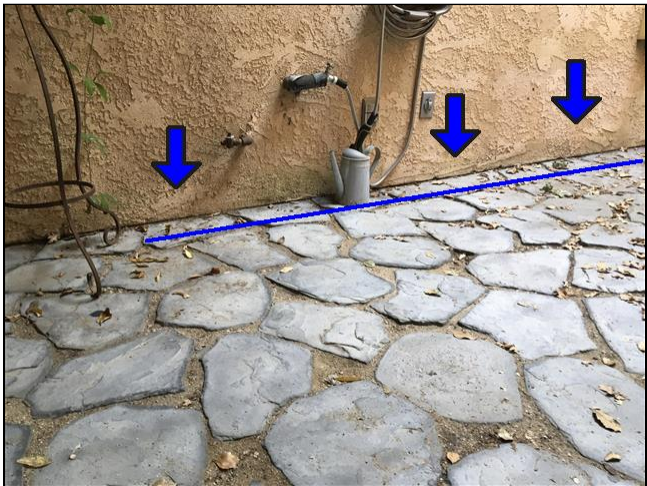
1.0 Item 1(Picture)

Soil or landscape materials are pushed up against the stucco siding at various areas around the home. Landscape maintenance is needed to remove material from holding moisture at the siding while maintaining functional drainage away from the foundation.

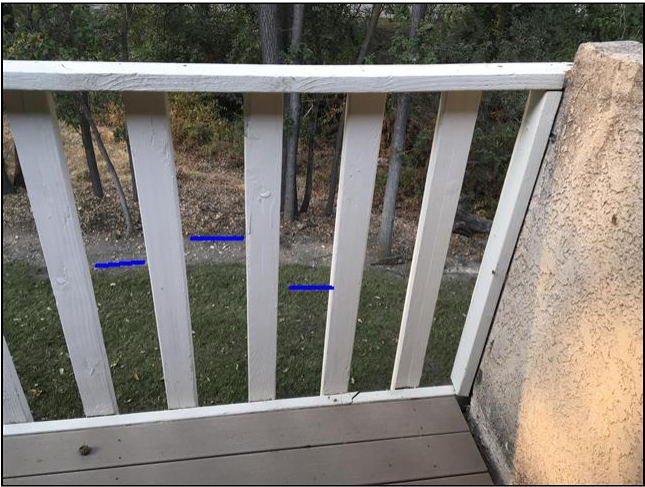
1.1 Item 1(Picture)

Guardrail baluster spacing exceeds 4" inches and upgrading to current standards is recommended for improved safety.

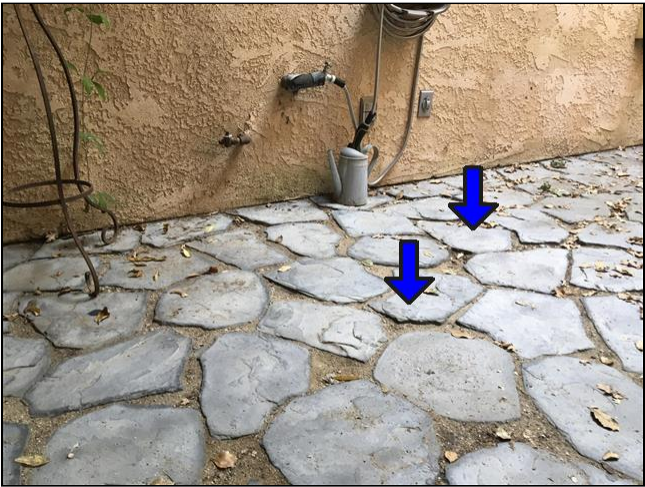
1.3 Item 1(Picture)

Uneven walkways noted at various areas of the home, creating possible trip hazards. Any variance in walkway height more than 3/4" needs properly ground down or filled in to improve the safety of the walkways.

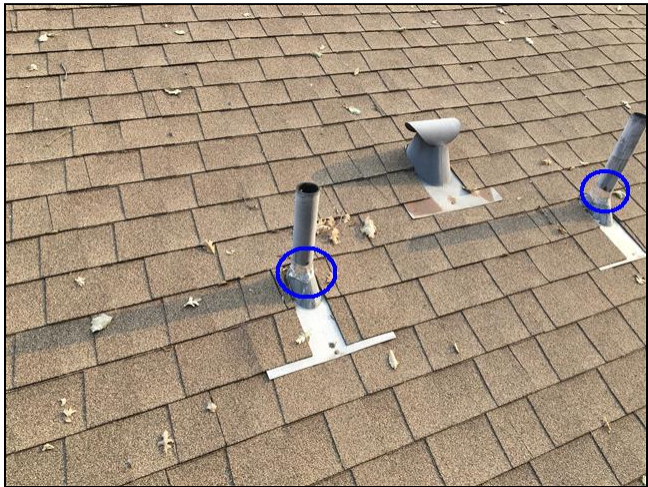
2.2 Item 1(Picture)

(1) MAINTENANCE NEEDED  
Plumbing vents need resealed at the roof.

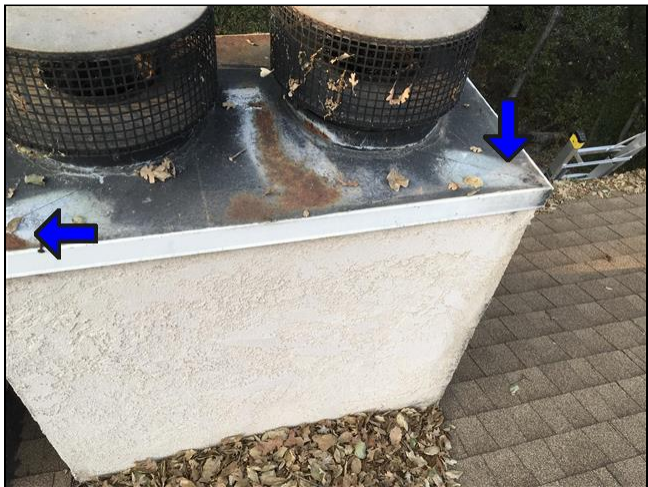
2.2 Item 2(Picture)

Chimney chase cap fasteners installed in the top of the chimney and need sealed with roofing caulk to help prevent moisture intrusion into the chase.

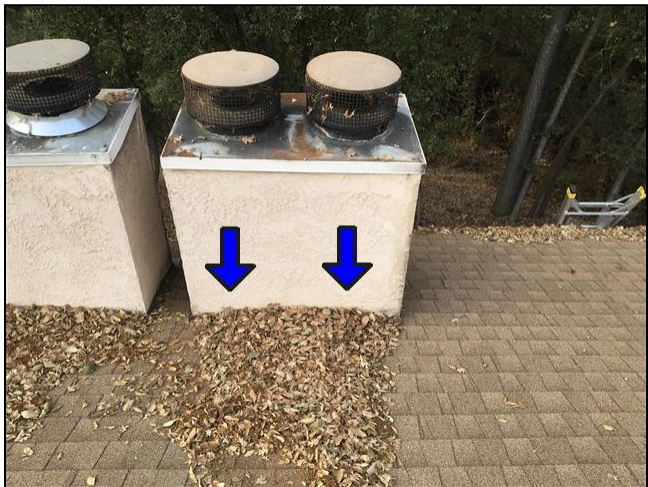
2.2 Item 3(Picture)

Proper chimney "cricket" metal flashing is not installed. While this may not have been required at the time of construction, installation of this component is recommended to prevent excessive debris build up and pooling moisture that may enter the building.

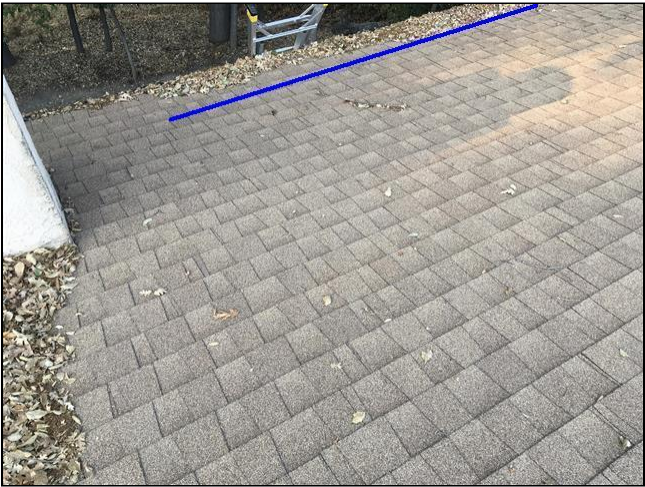
2.3 Item 1(Picture)

The gutters contain debris in areas and need cleaned and an annual maintenance schedule established to allow intended drainage of roof runoff water away from the home.

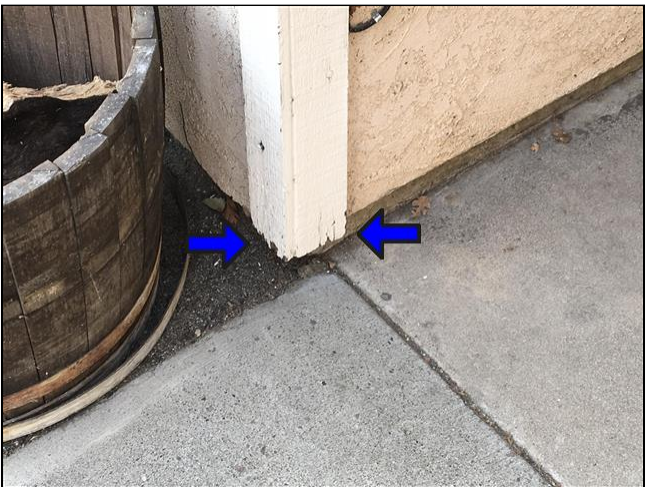
2.4 Item 1(Picture)

Areas of the trim contain moisture damage. Refer to the pest report for more information on this condition and make repairs as prescribed.

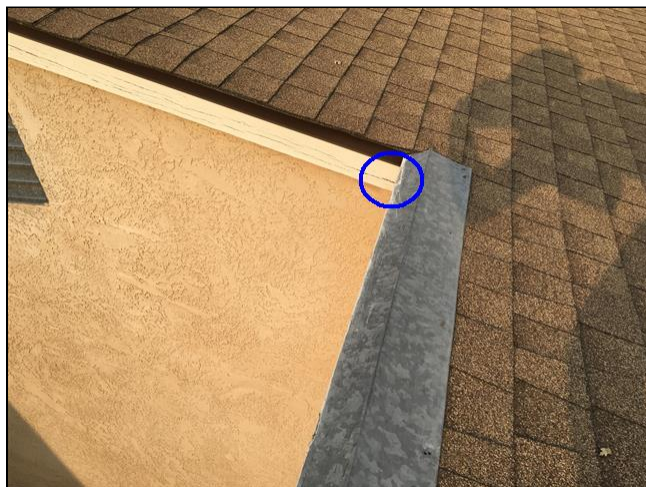
2.4 Item 2(Picture)

Areas of the fascia contain moisture damage. Refer to the pest report for further information on this condition and make repairs as prescribed.

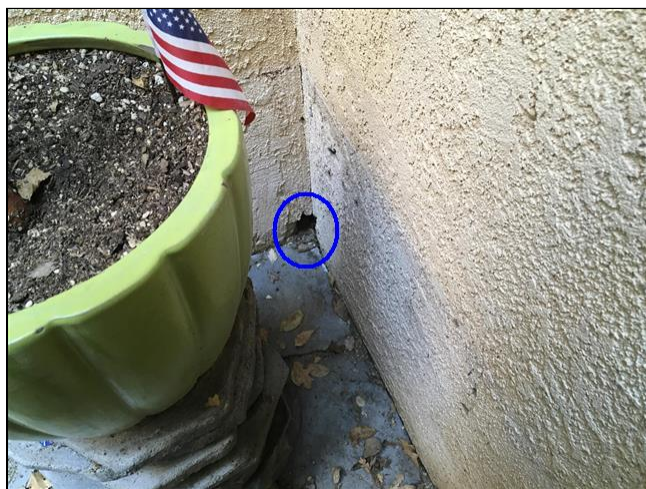
2.4 Item 3(Picture)

Stucco damaged at the exterior back left corner of the garage. Recommend repairs made to seal the area from weather exposure and improve cosmetics.

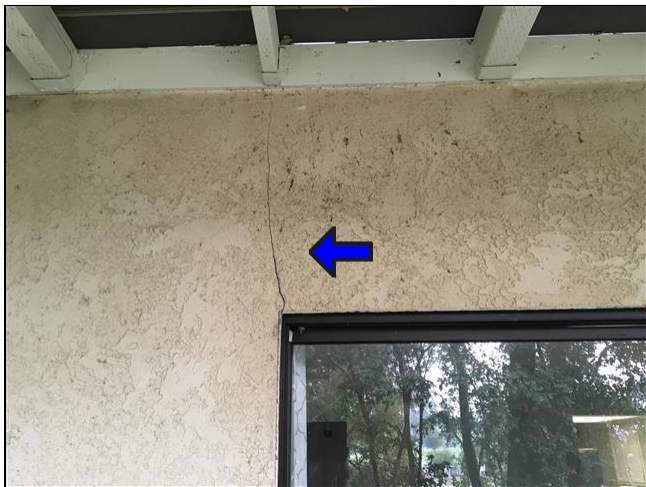
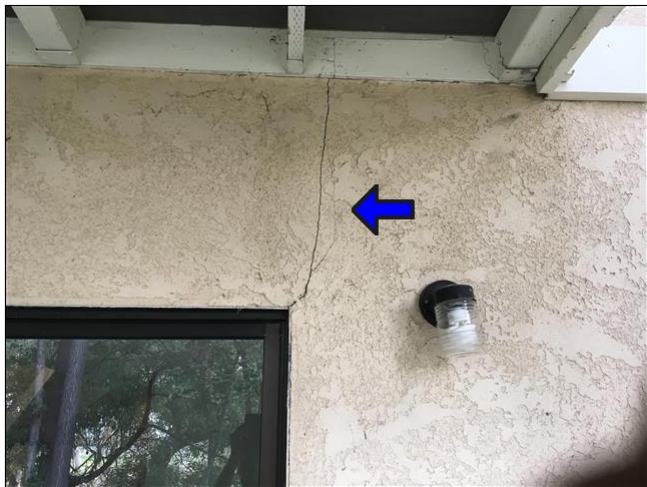
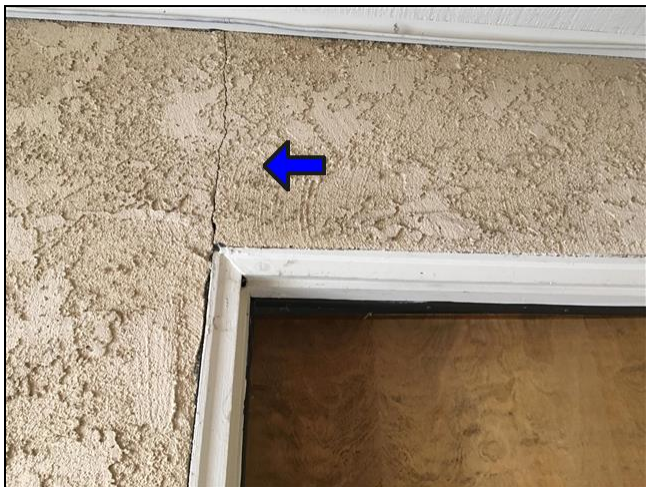
Slight stucco cracking noted at various areas around the building. This can be typical with stucco siding, and minor settling due to the age of the residence. Cracks should be sealed at the next paint maintenance interval to improve cosmetics and prevent further weather exposure.

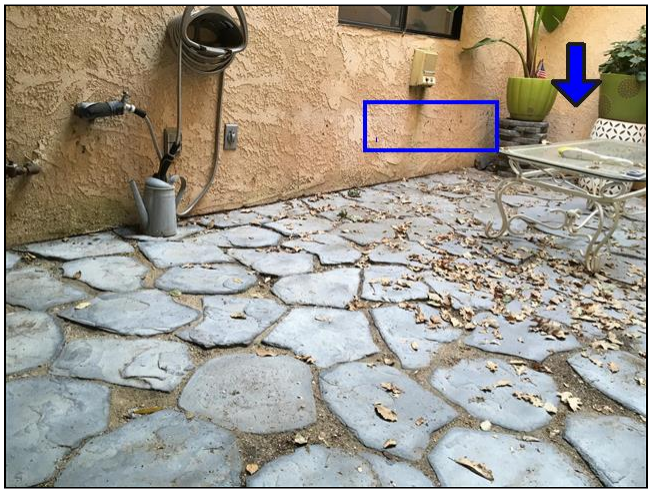
2.4 Item 7(Picture)

Perforations in the stucco siding at the front patio located between the residence and garage should be patched or repaired to prevent pest or moisture intrusion.

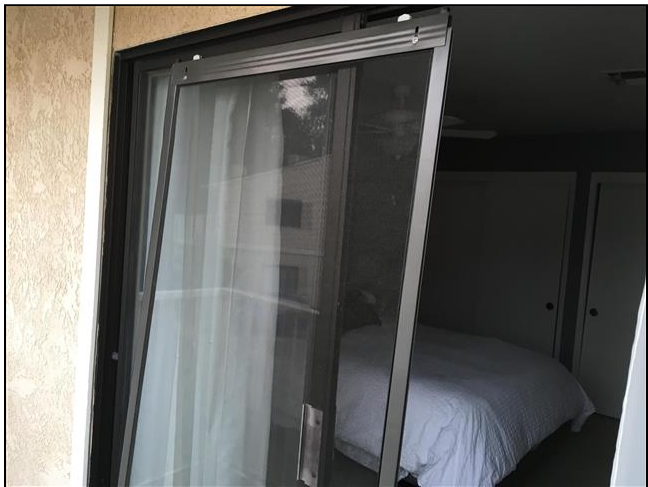
2.5 Item 1(Picture)

Screen door at the master bedroom deck is off the track and not functioning as intended.

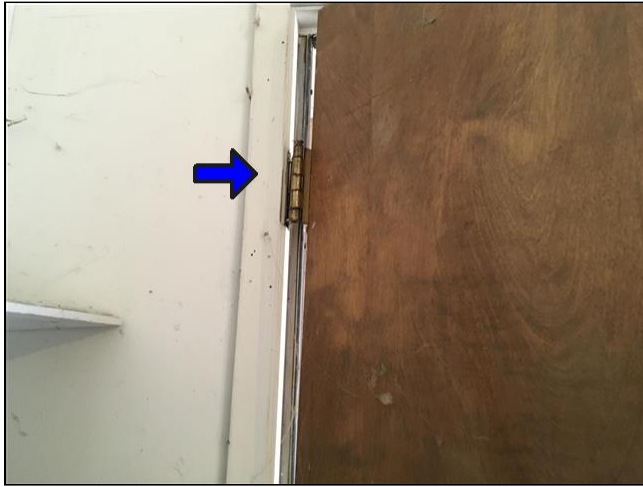
2.5 Item 2(Picture)

The garage man door is loose at the hinges and is dragging the jamb. Recommend proper tightening or adjustment at the hinges to prevent excessive wear to the door and jamb material, and to insure proper operation.

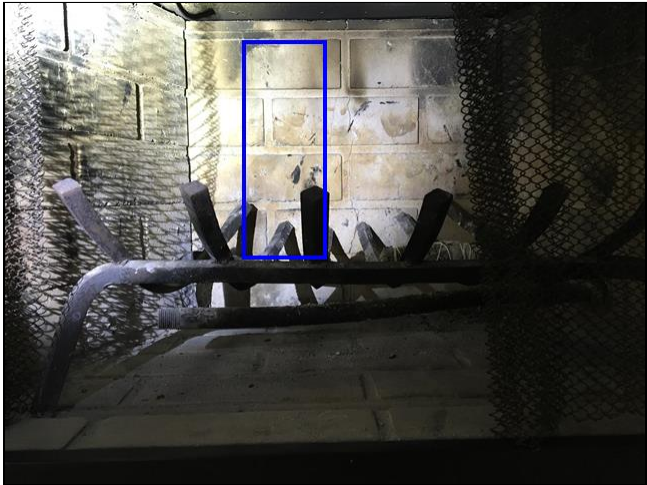
4.0 Item 1(Picture)

Fire-brick is cracked in the fireplace. Recommend further evaluation and repairs as needed by a qualified fireplace technician before further use.

(2) FURTHER EVALUATION  
Fire-brick is cracked in the fireplace. Recommend further evaluation and repairs as needed by a qualified fireplace technician before further use.

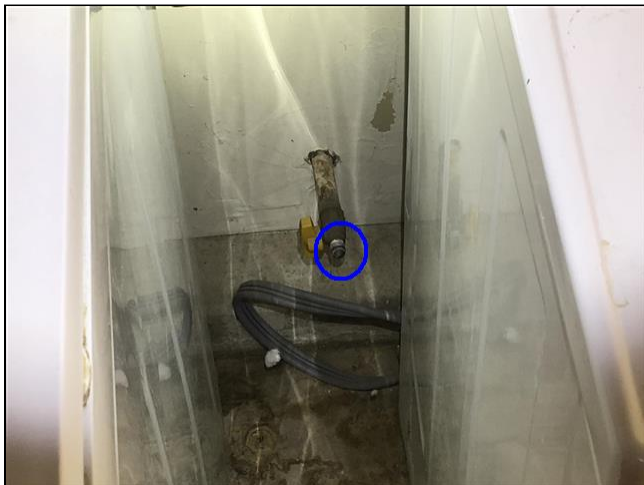
6.3 Item 1(Picture)

Cap needed on the gas valve at the laundry area and should remain in place until a gas appliance is connected in case of accidental opening of the valve.

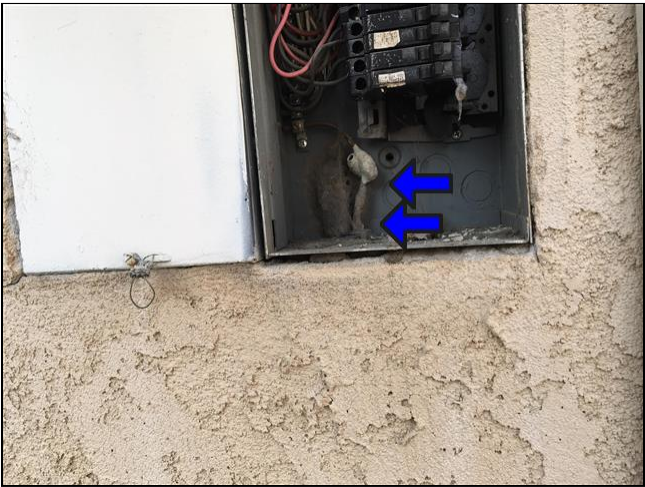
7.1 Item 1(Picture)

Pest intrusion noted behind the dead cover in the main panel. Recommend proper cleaning and removal of all organic material to prevent a possible safety hazard or system failure.

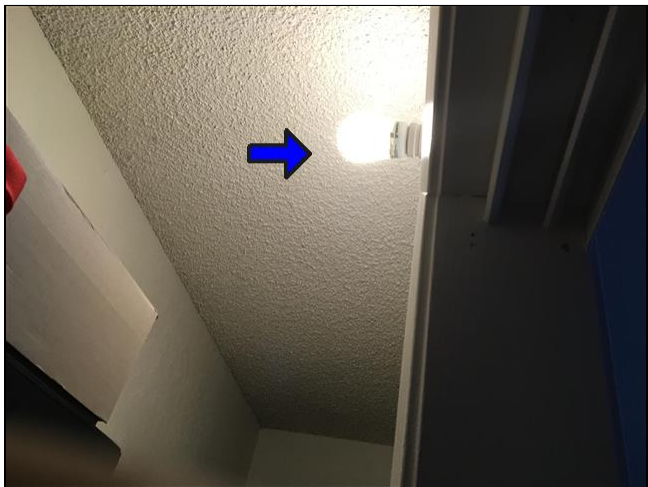
7.5 Item 1(Picture)

Light in the master bedroom closet needs a proper fixture installed to provide protection to the bulb from accidental contact.

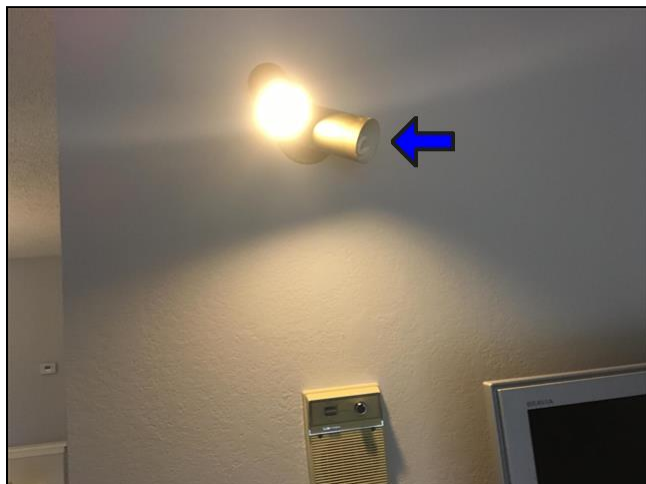
7.5 Item 2(Picture)

Lighting inoperative at the upstairs living room. Probable bulb failures noted. Replace or repair as needed.

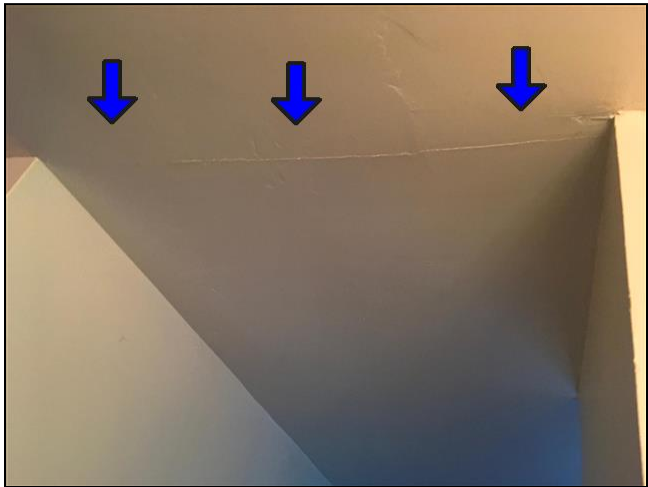
9.0 Item 1(Picture)

REPAIR AS NEEDED  
Common drywall cracking noted in a few areas and can be cosmetically repaired, as needed.

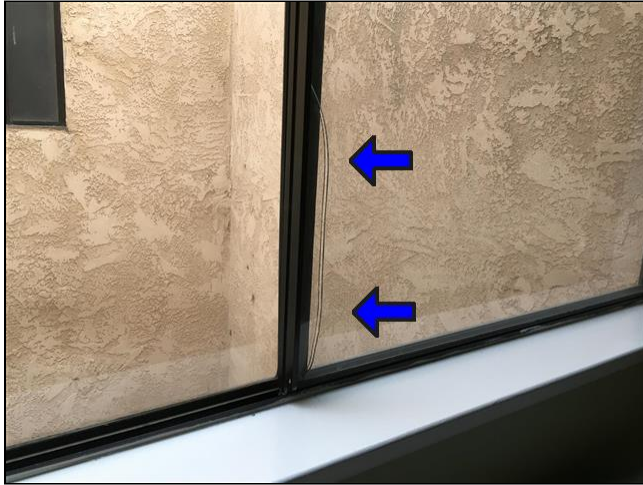
9.3 Item 1(Picture)

Cracked window noted at the interior of the window in the bedroom at the top of the stairs and should be repaired to prevent further damage and an unsafe condition.

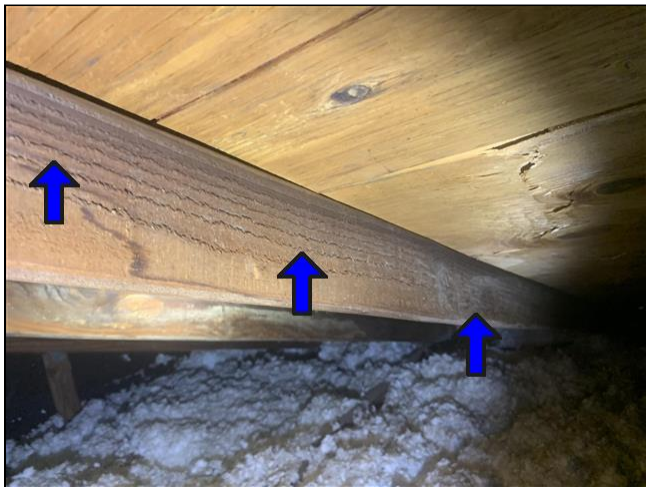
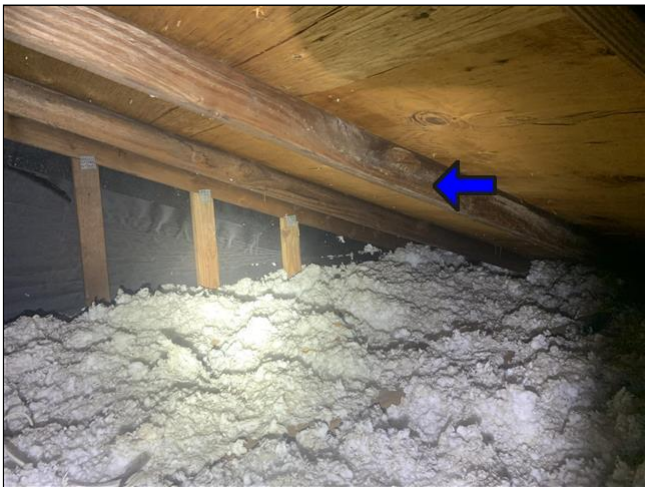
While acceptable at the time of construction, attic ventilation appears insufficient and installation of additional ventilation may be necessary. Refer to a qualified roofing contractor, as needed, to determine type and location of additional ventilation needed.
